Chapter 1: Purpose and Need

The Utah Department of Transportation (UDOT), in conjunction with the Federal Highway Administration (FHWA), is proposing right-of-way acquisition and safety improvements along SR-12 between Escalante and Boulder in Garfield County, Utah located from mile post (MP) 59.8 to 86.3. SR-12 is located in south-central Utah and is the only principal highway that runs east of Panguitch, linking US 89 with SR-24. SR-12 connects the communities of Tropic, Cannonville, Henrieville, Escalante, Boulder, Grover, and Torrey in Garfield and Wayne Counties.

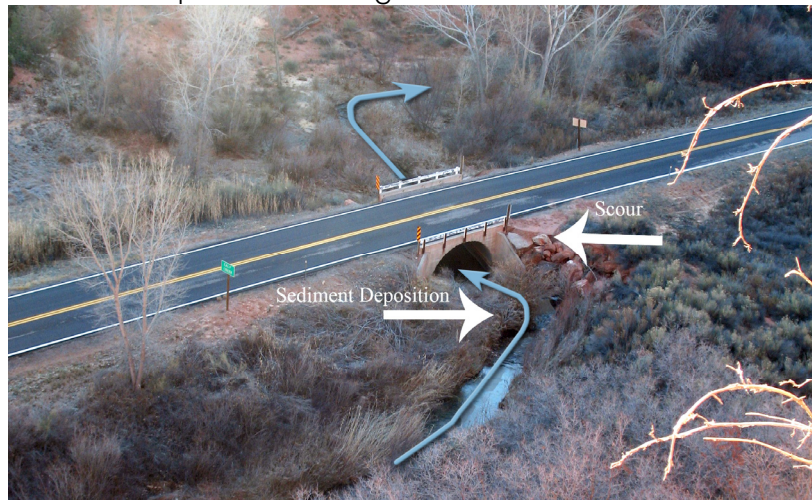
Graphic 1. 1: Existing Flow Path of Calf Creek

More specifically, the Calf Creek Bridge is a structurally deteriorated, steel-plate, pipe structure that was constructed in 1964. The creek generally runs parallel to the highway between the Calf Creek Recreation Area and the Escalante River before making a sharp turn immediately upstream of the bridge. Due to the skewed approach, the creek flows erode the southwest abutment on the inlet end and create sediment deposition on the north side of the creek under the highway. Scour attacking the Calf Creek Bridge is eroding the fill slope and compromising the pavement section.

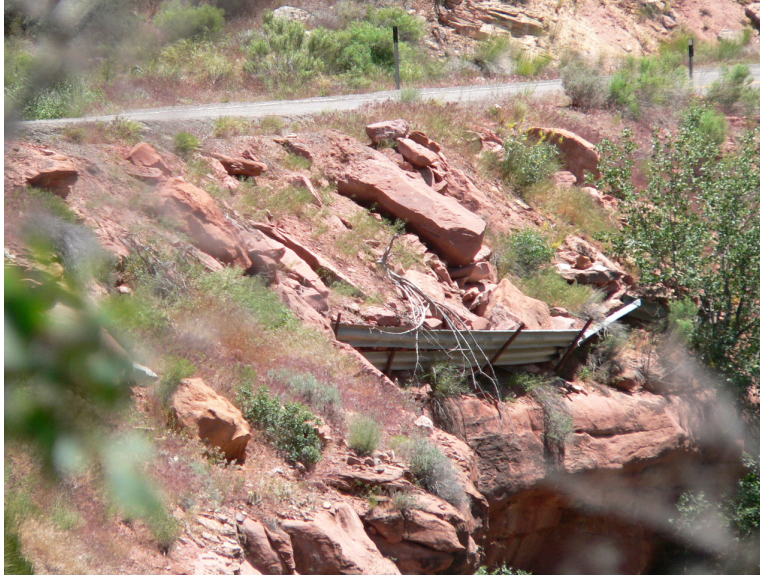
Graphic 1. 2: Milepost 74.8—Unstable Location

which typically need larger widths to maneuver turns. In particular, there is an unstable location at MP 74.8 where the side slope is being held in place by guardrail, as shown in the photo below. If this makeshift support system fails, part of the roadway will collapse.

The unstable rock and erosion also play large roles in the deteriorating foundation that supports the road. It is difficult with steep side slopes to maintain the stability of the shoulders adjacent to the travel lanes. The road breaks away at the edges as a result of water run-off and lack of support from the fill slopes. The breaking edge of pavement minimizes the usable road width and compounds the hazards of tight curves to larger vehicles—such as trucks, trailers, and RVs—

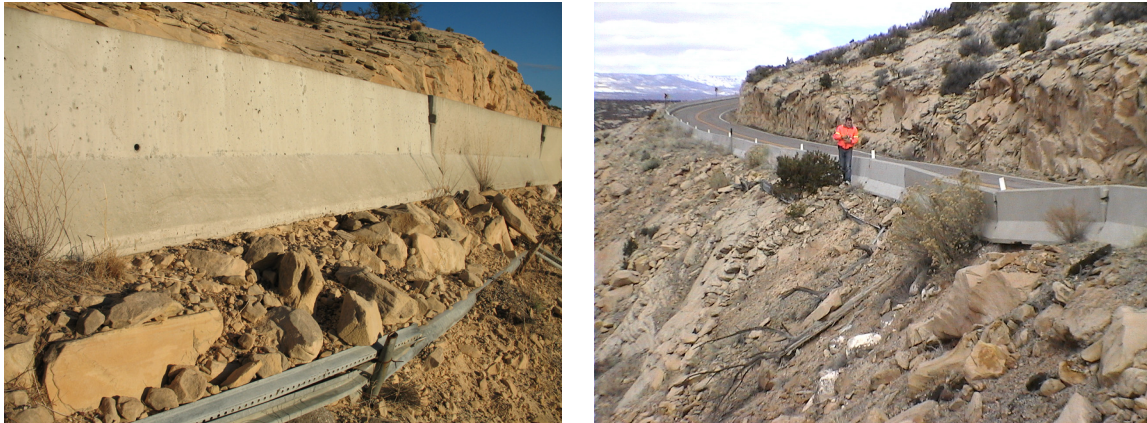
Graphic 1. 3: Unstable Barrier from MP 77.5 to 77.7

Unstable shoulders and side slopes also cause the instability of roadside barriers and guardrails. At MP 77.5, a section of concrete barrier is supported only by the pins and barrier sections on

either side; there is no pavement below. Many of the side slopes along the road are 3:1 or steeper and are not protected by a barrier or guardrail.

At MP 75.4 and from MP 77.5 to 77.7, sections of pavement have sloughed off under the unsupported concrete barrier. Examples are shown in Graphics 1.3 and 1.4.
